Conservation of Teferi House As A Museum

A Project Proposal for Rehabilitation of the Teferi House
that will have new function after maintenance and
modifications

March, 2009

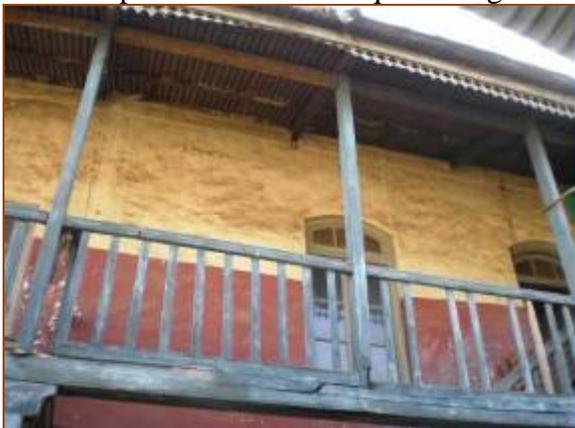
Fig.3.2. Painting done recently which is inappropriate

In an effort to document the form, type and color of coatings such as paint; and the condition of exterior wood features prior to beginning project work were done and it is found the coatings of the buildings are entirely lost. The present colors are recent inappropriate additions to the building by poor inhabitants that occupied the building for the last 40 years.

Regarding the paint it will be necessary to repaint the wood -if possible lacquer if not varnish. And the same white and blue paint on the internal and external walls as these are colors that are appropriate to the building and the old town.

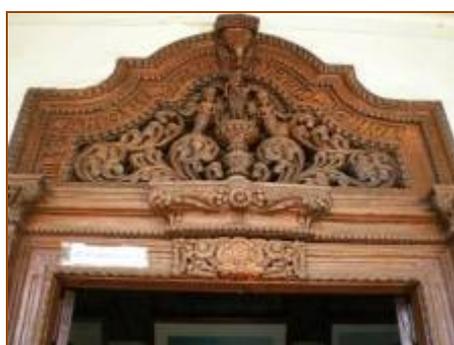
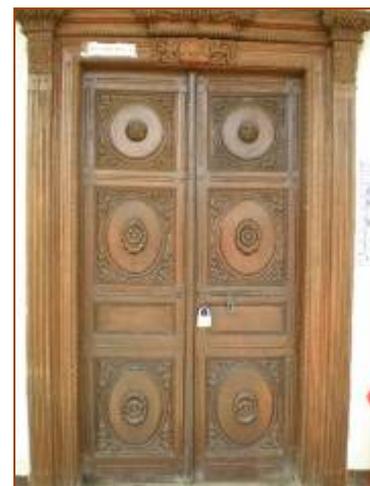
Fig 3.3. The main front door is in a good condition.

Almost all part of the exterior wood surface is damaged. The parts that need cleaning rather than repainting are almost nil except that of the front door at the ground floor, which is in a good condition.

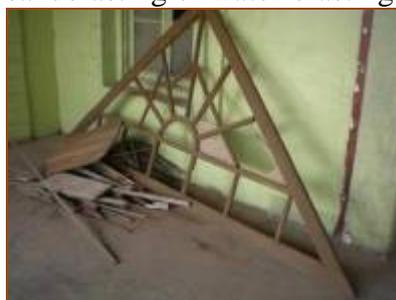
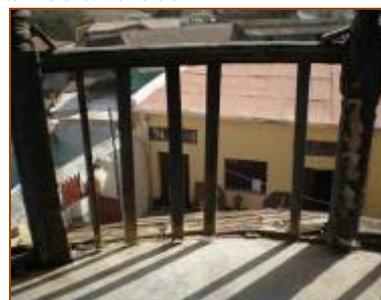
Decorative wood elements especially are completely stripped of their paintings. Some are even cracked physically damaged.

Fig.3.4. Decorative Elements are missing or damaged in lots of places especially the first floor front features.

The first floor front feature where there are wooden features of cornice and balustrade are missing or highly damaged.

Conservation work in these wooden elements should be done by Removing damaged or deteriorated paint to the next sound layer using the gentlest method possible (scraping and sanding by hand), then repainting in kind. If hot-air guns are used it shall be used carefully. Destructive paint removal methods such as propane or butane torches, sandblasting or water-blasting shall be avoided.

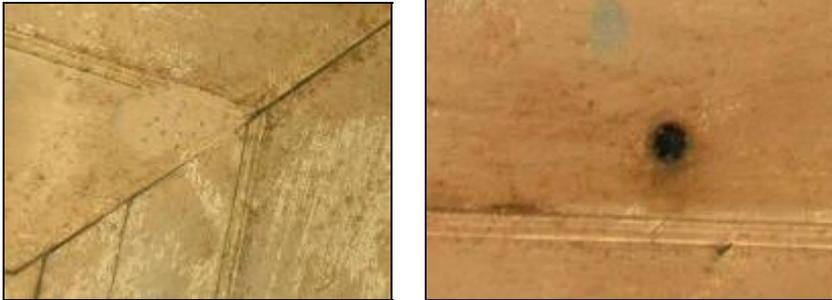
The first floor is the most damaged part. Insect infestations on some parts of the wood are seen on the first floor rooms and also on the outside part of the whole building.

Fig.3.5. Insect infestation on the ceiling of the first floor

The causes of infestations shall be treated immediately; vents needs to be opened, treating active infestations of insects by first identifying the type of insect and then implementing a program of elimination appropriate to that insect.

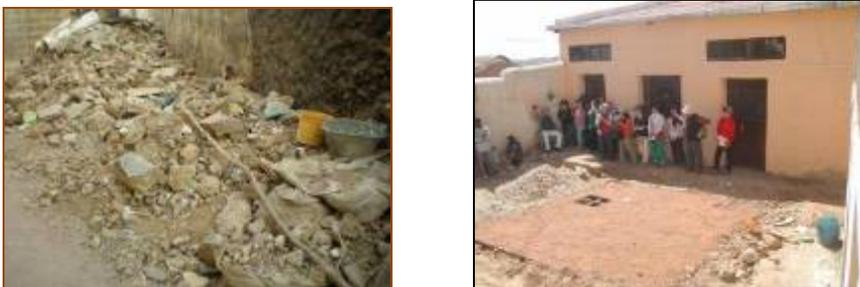
The water drainage structures are badly damaged. The gutters are leaking here and there. There are cracks and holes in sidings, piled up earth resting against the building and vents are closed. All these has created a problem in weathering.

Fig.3.6. Piled up earthing against the building, and inappropriate water reservoir building works in the compound.

What to be done, in this case is prevent water penetration and maintain proper drainage and re-moving piled up earth resting against the building and applying a chemical preservative treatments, to arrest dampness.

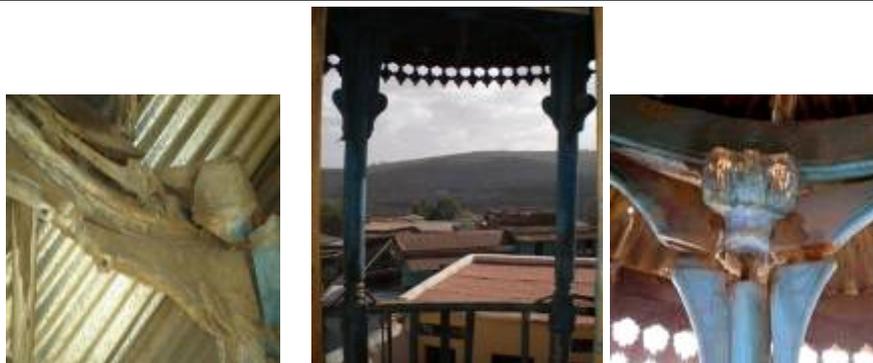
Columns, both on the ground and first floor are deteriorated. Cracks and structural weaknesses are witnessed. Nevertheless more scientific study beyond mere observation is needed to talk about the stability of the building. The capitals in the first floor are also in bad shape as shown in fig.

Fig.3.7. Columns and associated decorative elements are deteriorated

One column is in bad condition and may be needed to be replaced, if so, substitute wood column shall convey the same form, design and overall appearance and at least be equal to its load-bearing capabilities.

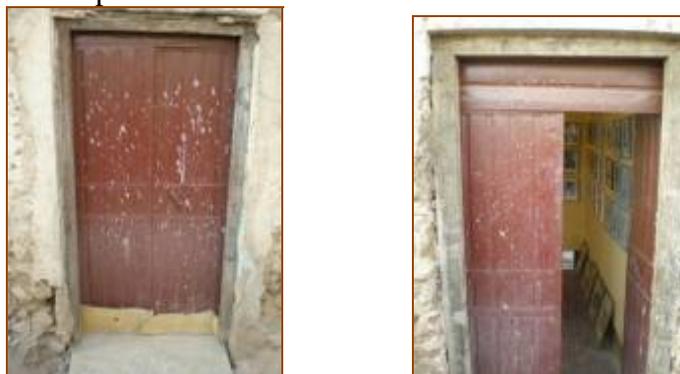
Some of the original doors are missing and already replaced by totally unacceptable iron doors.

Fig.3.8. In appropriate metal doors, which shall be removed

Extensively deteriorated or missing parts of all exterior wood elements shall be replaced in kind where there are surviving prototypes. The new work should match the old in form and detailing. If using the same kind of material is not technically or economically feasible, then a compatible substitute material may be considered. The metal doors which are alien to the house architectural style need to be removed and replaced by wooden doors. The new doors can be a new design that is compatible with the style, era and character of the historic place; or a replica based on physical and documentary evidence.

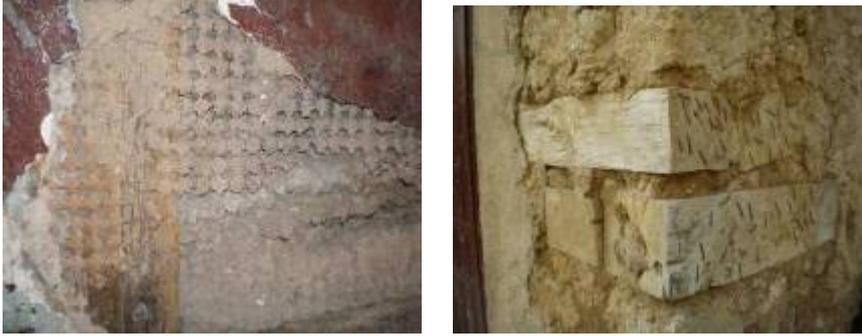
The conditions of the masonry walls, door surrounds, pediments, and details of jointing, tooling, bonding patterns, coatings, color, and conditions of these elements are assessed and the summary is put here. The masonry wall is basically done with old techniques of using limestone and related earthen materials. The ground floor masonry is somewhat better than the first floor where the masonry is very dirty and soiled caused by soot, graffiti and other factors. On some places it is even in pretty bad shape of crumbling away. Deteriorated Mortar joints, loose stones, damp walls or damaged plaster work are all over the building which is seen in many areas. Water I also penetrating the

building masonry in the back of the building, where it is creating a serious problem of dampness.

Fig 3.9. damages to the masonry from 1rst floor and ground floor accordingly.

What needs to be done regarding these problems with the masonry is cleaning it using recognized preservation methods and only when necessary to halt deterioration or remove heavy soiling and graffiti. Cleaning masonry surfaces shall be done using the gentlest method possible, such as low-pressure water and detergents, using natural bristle brushes.

The masonry walls and other masonry elements shall be repaired by re-pointing the mortar joints where there is evidence of deterioration such as disintegrating mortar, cracks in mortar joints, loose bricks, and damp walls or damaged plaster work. Mortar should be compatible in strength, porosity, absorption and vapor permeability with the existing masonry units. With regard to water percolation in the back of the house, we need to apply new or non-historic surface treatments such as proven water-repellent coatings to masonry after repointing repairs, Paint in many part of the building is deteriorated badly.

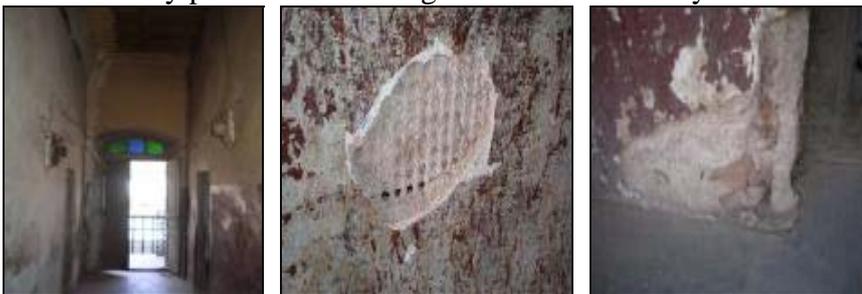
Fig.3.10. Deteriorated paint on different part of the house

Treatment of the paints on the wall will mainly include removing damaged or deteriorated paint only to the next sound layer using the gentlest method possible (e.g., hand scraping) prior to repainting, repainting with colors that are historically appropriate to the building and the old town of Harar.

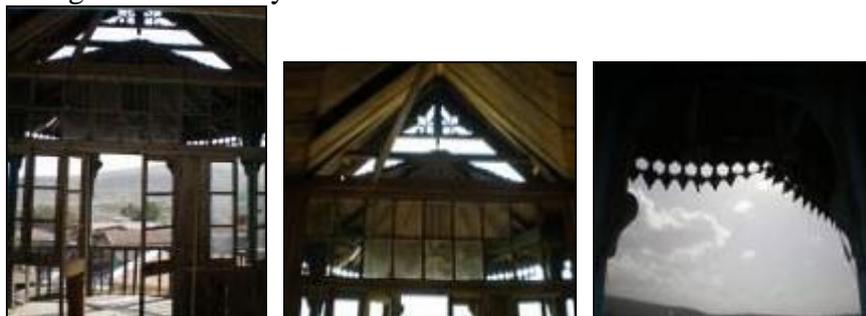
One of the first architectural metal elements that attract an attention is the claddings on the first floor which are deteriorated due to corrosion

and extreme weathering where some are missing, but still beautiful enough to catch an eye.

Fig 3.11. Iron claddings corroded and deteriorate

To Protect and maintain the architectural metals of the cladding from corrosion, apply method that will prevent water penetration and by maintaining proper drainage so that water or organic matter does not stand on flat, horizontal surfaces or accumulate in curved, decorative features. Clean the metals, to remove corrosion prior to repainting or applying other appropriate protective coatings.

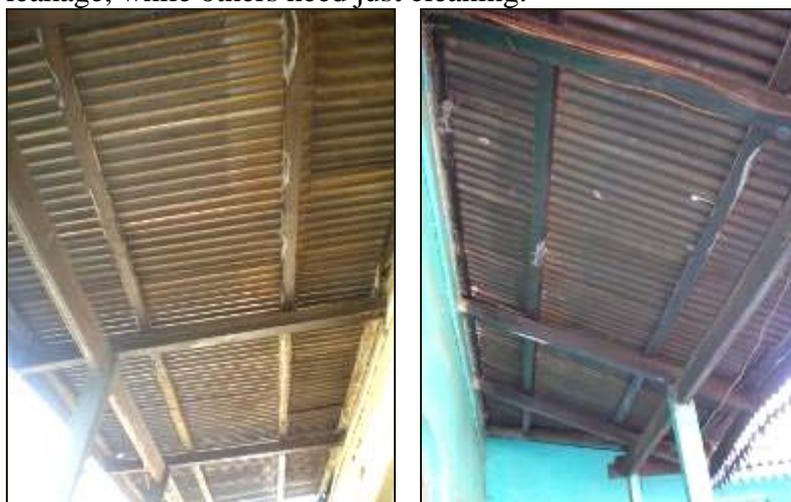
The roof top is fully covered with corrugated iron sheets, which are still there but deteriorated lot. Some needs replacement as there is leakage, while others need just cleaning.

Fig.3.12. Roof top iron sheets are corroded

Remedies will include cleaning and maintaining the gutters and downspouts and replacing deteriorated flashing in kind. Roof sheathing should also be checked for proper venting to prevent moisture condensation and water penetration; and to ensure that materials are free from insect infestation, There I also a need for provision of adequate anchorage for roofing material to guard against wind damage and moisture penetration.

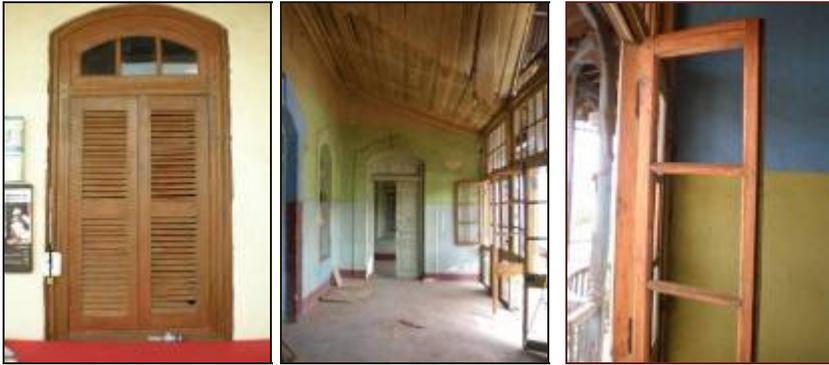
The windows are all made of woods. The ones at the ground floor are in good shape, except in two windows there are small missing

elements and dentures. But on the 1st floor the windows are damaged a lot. Woods damaged, glasses broken. Some windows are completely stripped of their glasses.

Fig.3.13. Windows are damaged, which needs a lot glazing work

To Protect and maintain the windows, the wood and architectural metals that comprise the window frames, sashes, and surrounds use appropriate treatments such as cleaning, rust removal, limited paint removal and re-application. Sound windows and window elements or deteriorated windows and window elements that can be repaired, shall be retained

Deteriorated windows and window elements shall be repaired and stabilized by structural reinforcement, weather protection, or correcting unsafe conditions, as required, until any additional work is undertaken. Repairs should be physically and visually compatible. window frames and sashes, will be repaired by patching, splicing, consolidating and reinforcing.

Extensively deteriorated or missing parts of windows will be replaced in kind, where there are surviving prototypes. The new work should match the old in form and detailing.

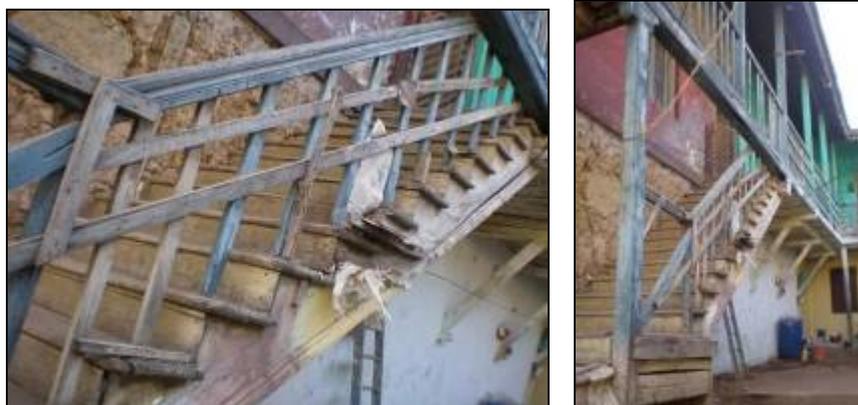
The stairs to the first floor, in the back of the main façade are in bad condition. (see the following fig.)

Fig 3.14. Dilapidated stairs to the first floor

Nevertheless the stairs in the back and the doors in the first floor are damaged and needs to be repaired thoroughly.

The deteriorated backdoor stairs elements need to be repaired by structural reinforcement, and correcting unsafe conditions, as required, until any additional work is undertaken.

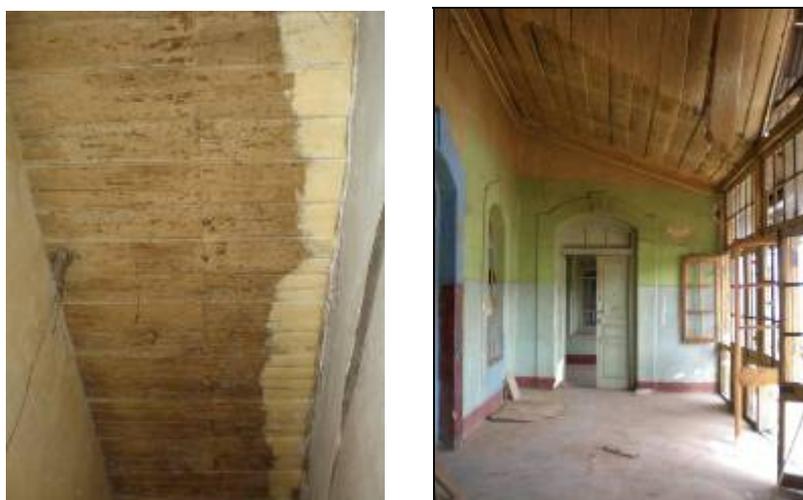
When we look at the interior space in the ground floor and the first floor, there are damages. The first floor interior spaces, has dirty and broken elements which needs cleaning and maintenance.

Fig 3.15. Decaying interior space

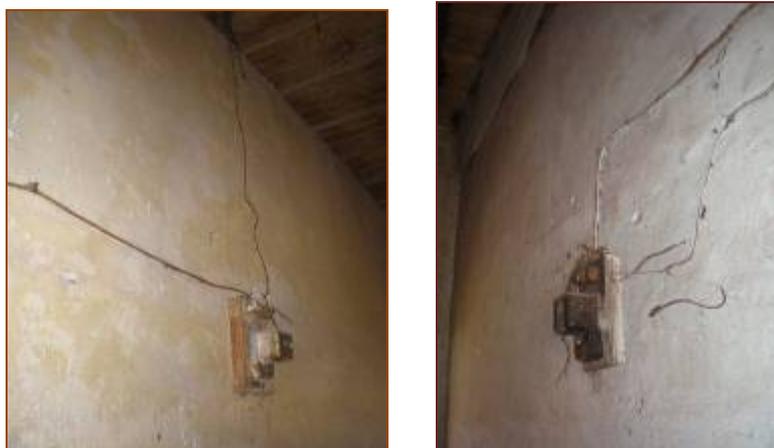
The electrical systems in the building are outdated, done in a hazardous way, and damaged in so many places. The one in the first floor is especially completely damaged.

Fig. 3.16. Inappropriate electrical wires

There is a need to dismantle the whole electrical system and add a new line and systems that will be compatible with the visual feature of the building. The cables shall be installed in non-character-defining areas.
