Conservation of Teferi House As A Museum

A Project Proposal for Rehabilitation of the Teferi House
that will have new function after maintenance and
modifications

March, 2009

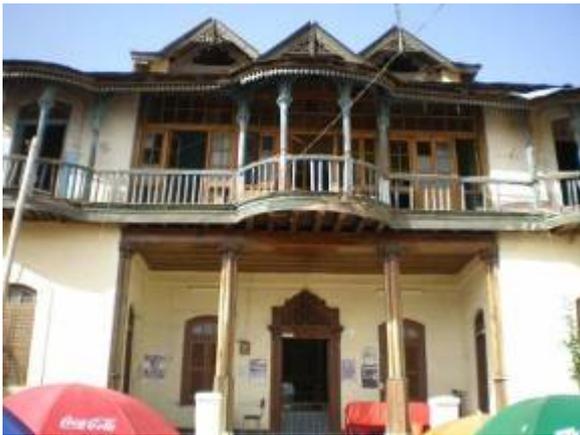
Fig.3.1. The Exterior Wooden Features of the Teferi ouse House

Exterior wood features of the house such as siding, corner boards, brackets, columns, window and door surrounds or architraves, cornices, pediments and balustrades; and their paints, finishes and colors — that are important in defining the overall heritage value of the building are still many. The missing elements of these features are little.

These external wood features will be retained and persevered using standard preservation techniques and guidelines.
